INVESTIGATION NO. 2726
THE PENNSYLVANIA RAILROAD COMPANY
REPORT IN RE ACCIDENT
AT SHORE, PA., ON
SEPTEMBER 6, 1943

Accident at Shore, Pa., on September 6, 1943, caused by a
broken journal.

Inv. No. 2726
Pennsylvania Railroad
Shore, Pa.
September 6, 1913

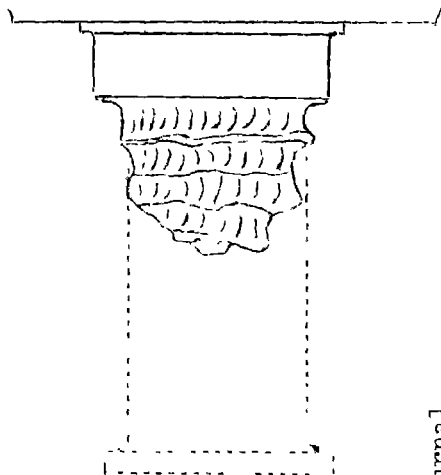
Broken journal
5-1/2" by 10"

After the accident it was found that the left front journal of the front truck of P. R. R. 1860, the seventh car, was broken off. Beginning at the heel of the west frog of the movable-point crossing and extending eastward 23 feet 4-1/4 inches, an angular flange-mark appeared on top of the head of the north rail. Extending from the east end of this mark a distance of 48 feet 8-1/4 inches to the heel block of the east movable point of the crossing, the ties bore wheel marks outside the north rail and inside the south rail. Immediately east of the heel block the track was torn up a distance of 480 feet, and from this point eastward it was damaged 1,056 feet.
